NBSIR 85-3158

Fire Performance of Interstitial Space Construction System

**U.S. DEPARTMENT OF COMMERCE
National Bureau of Standards
National Engineering Laboratory
Center for Fire Research
Gaithersburg, MD 20899**

May 1985

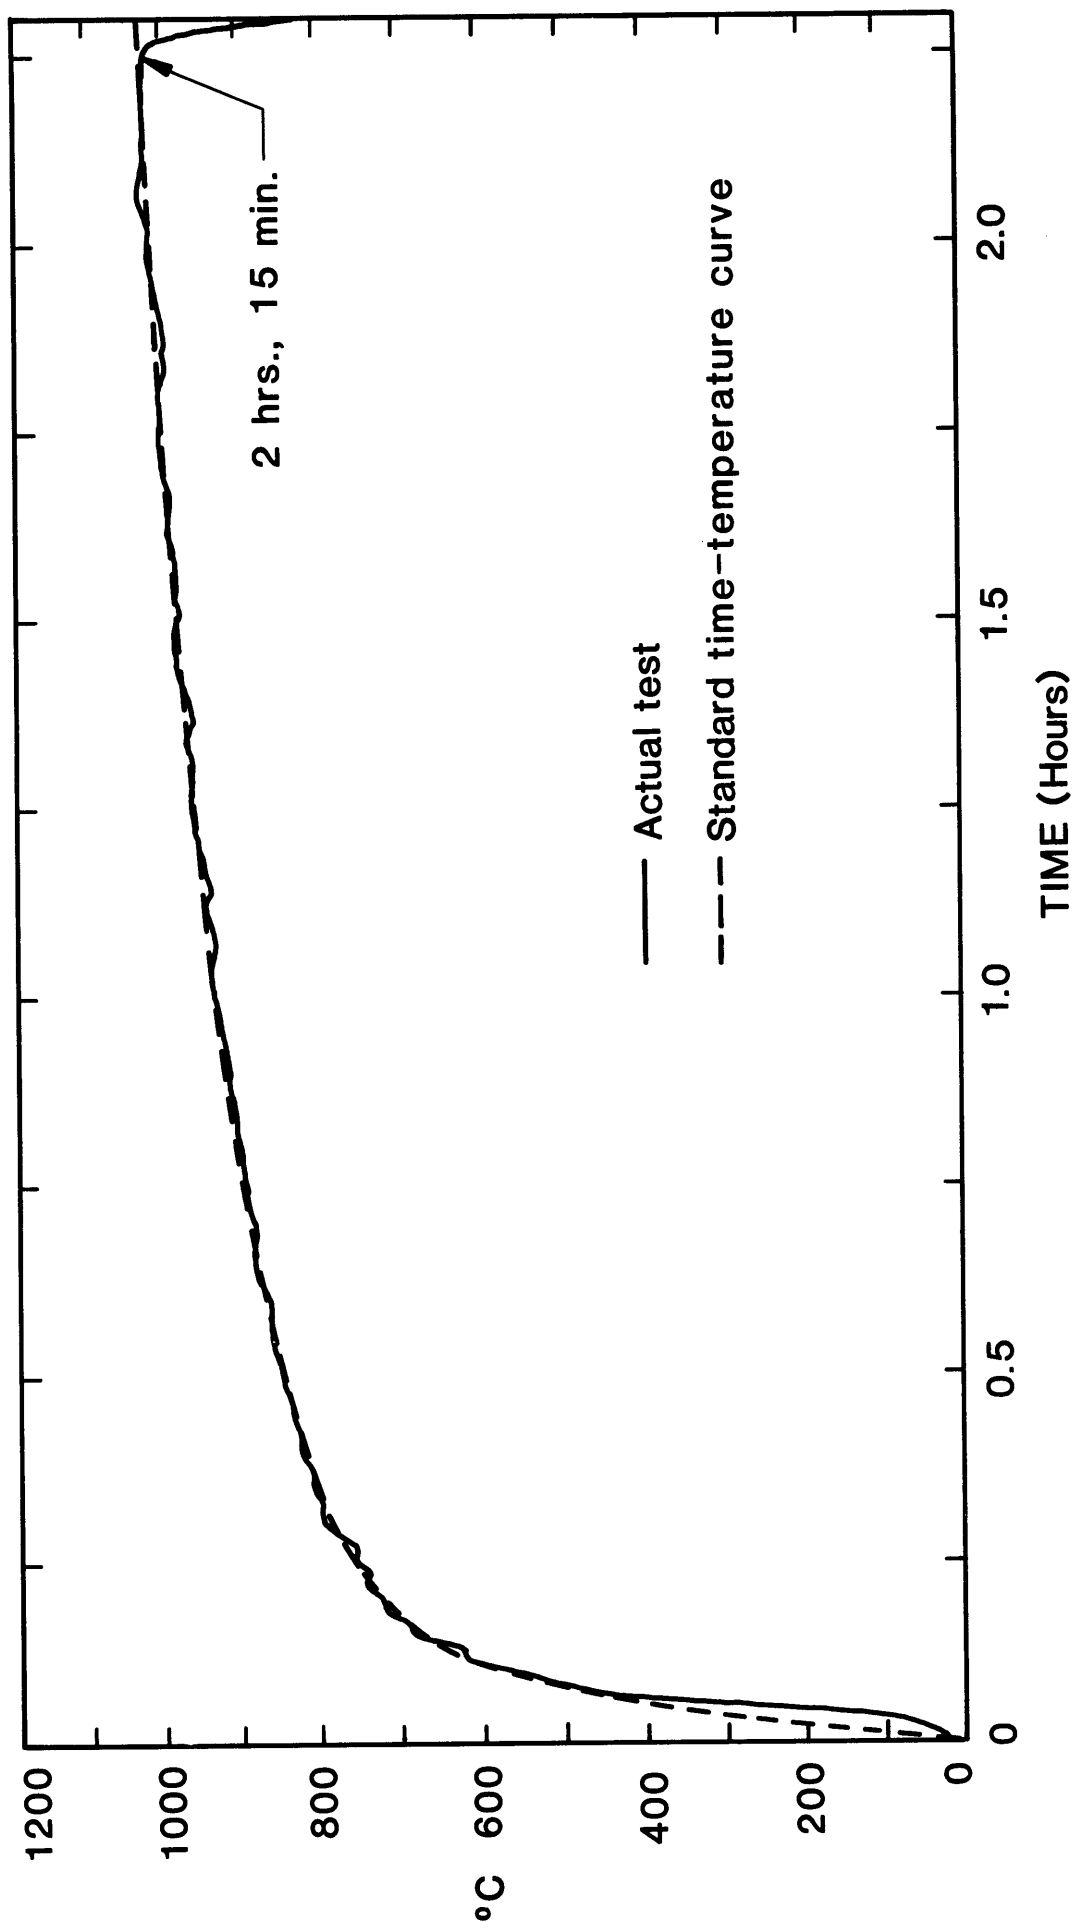
Figure 23. Chart record of average furnace temperature, test 1

The record of the average furnace temperature as compared to the standard time-temperature curve is shown in figure 23. The record shows a test duration of 2 hours, 15 minutes.

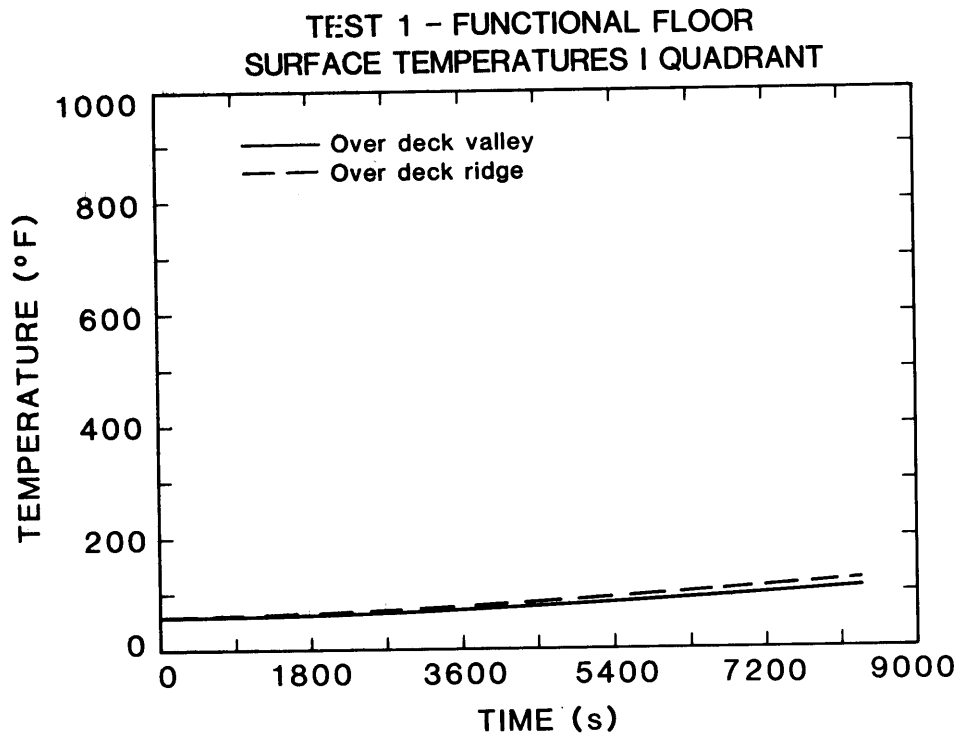
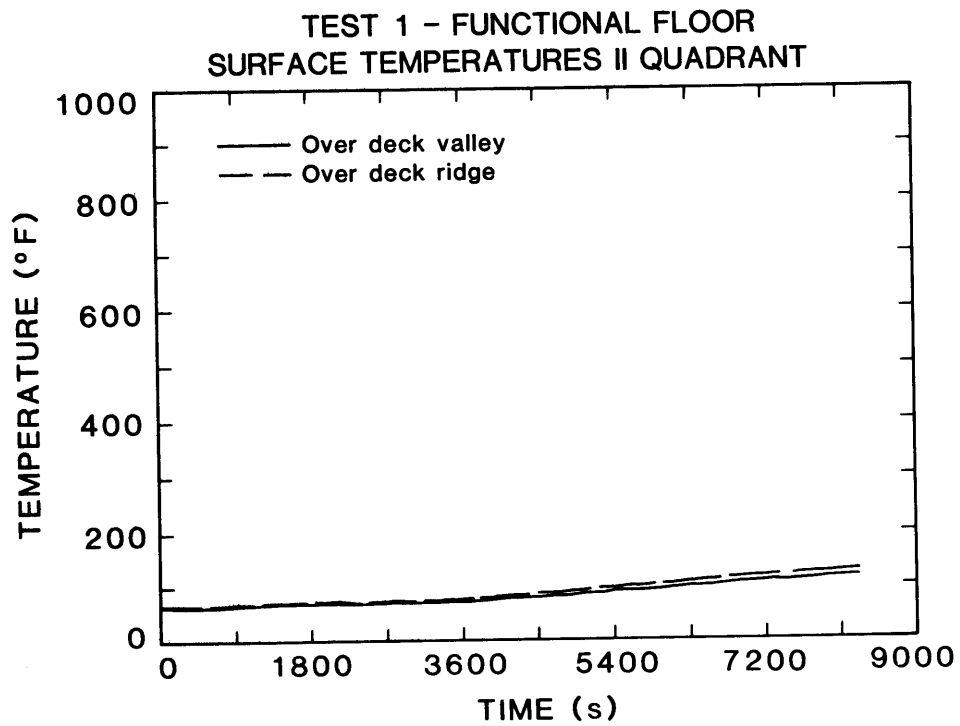
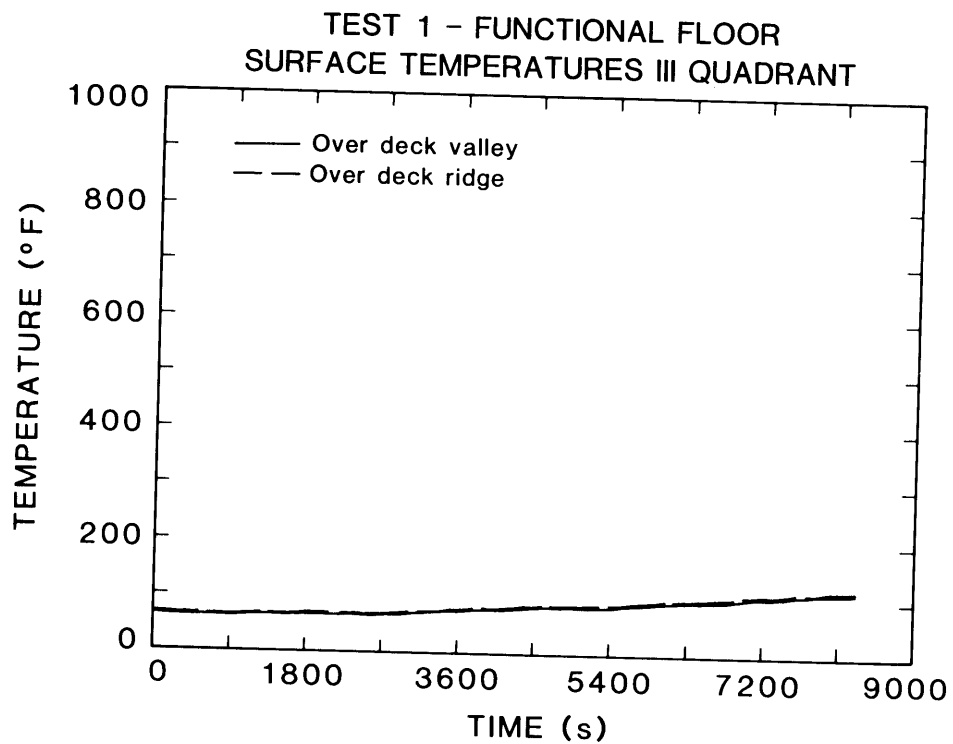
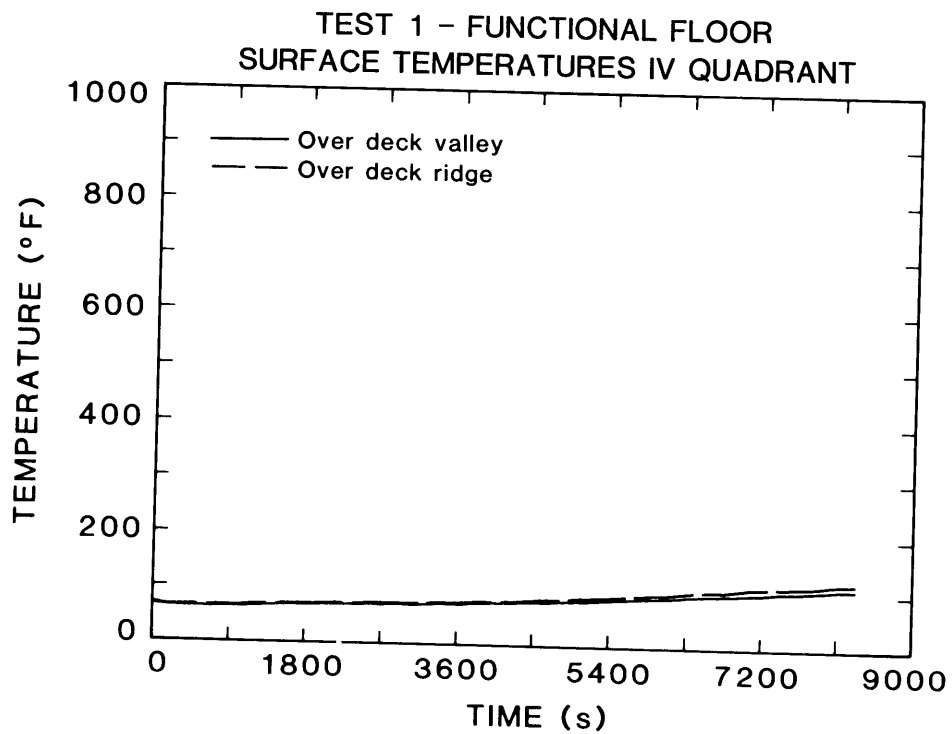
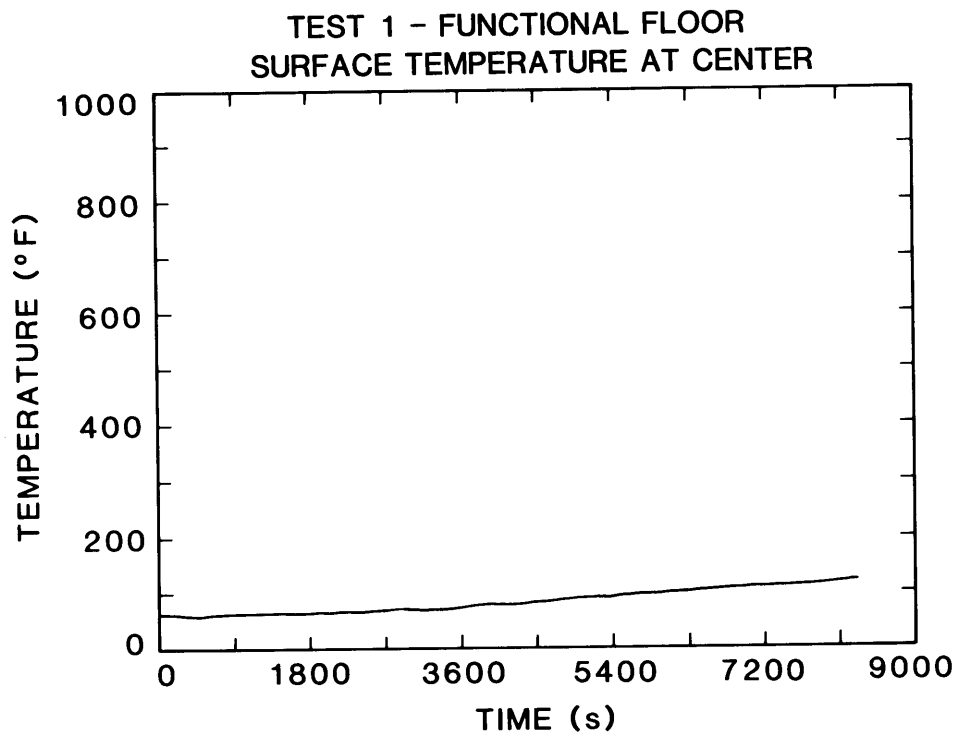
The critical temperature measurements mentioned in section 2, from NFPA 251, relate to the performance of the functional floor, unprotected steel in the interstitial space, and the W14x61 steel column. As can be seen in figures 25 to 29, all surface temperatures were well below the allowable 250°F temperature rise failure point at the test's end. As shown in figure 30, the functional floor's steel deck temperatures only approached 200°F. Figures 31 to 34 exhibit the temperature rise experienced with the unprotected structural steel elements in the interstitial space. These indicate relatively uniform distribution of heat in the interstitial space. Again, the temperatures on these structural elements were well below the failure temperatures at the maximum exposure time. These data show that the lightweight concrete walk-on deck system acted to provide significant protection to the steelwork in the interstitial space from the high temperature fire.

Figure 25. Functional floor surface temperatures quadrant I, test 1

Figure 26. Functional floor surface temperatures quadrant II, test 1

Figure 27. Functional floor surface temperatures quadrant III, test 1

Figure 28. Functional floor surface temperatures quadrant IV, test 1

Figure 29. Functional floor surface temperature center of test bay, test 1

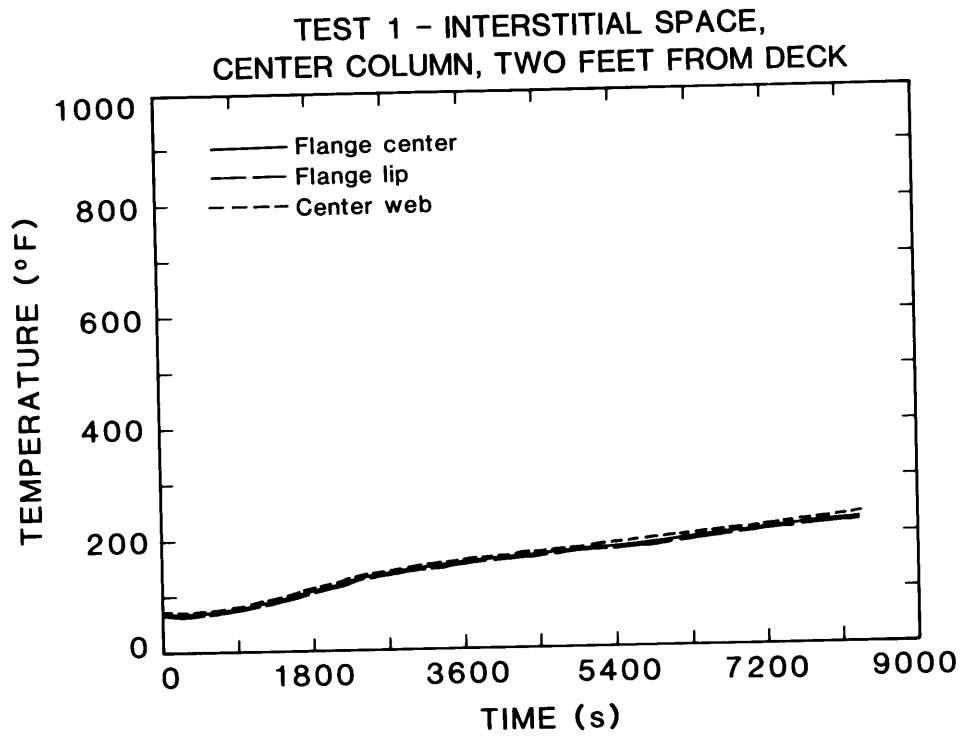
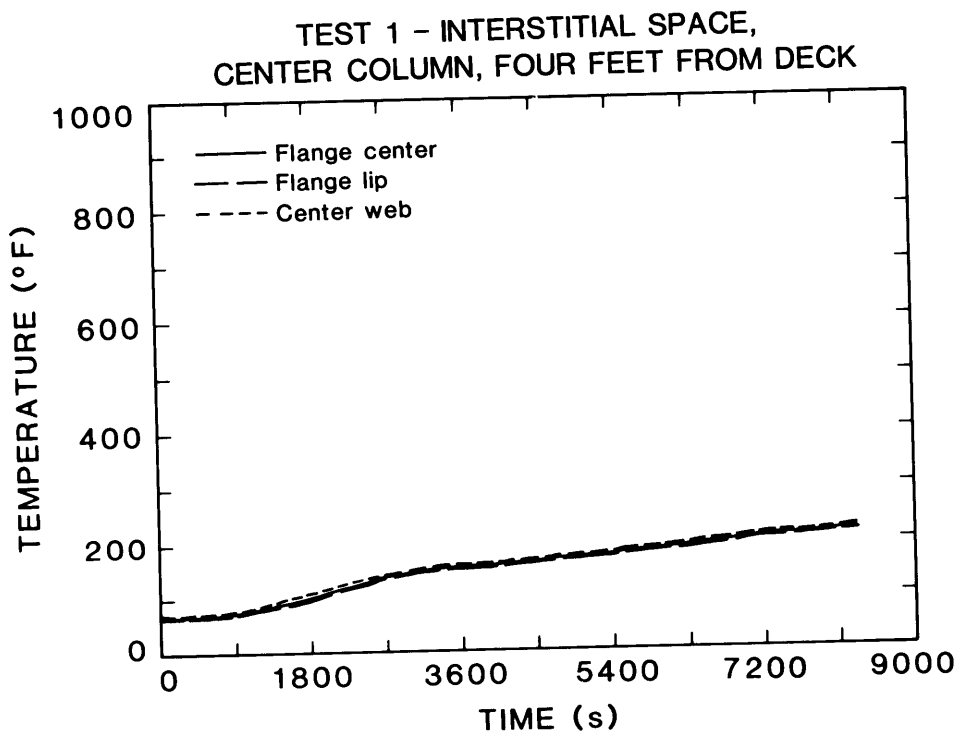
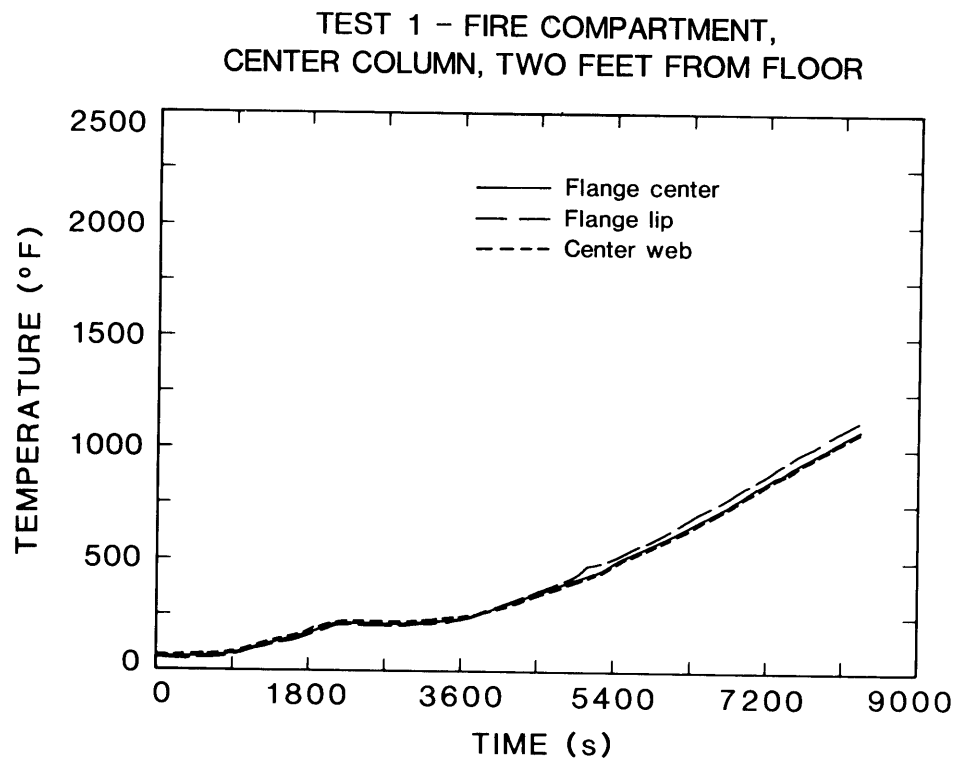
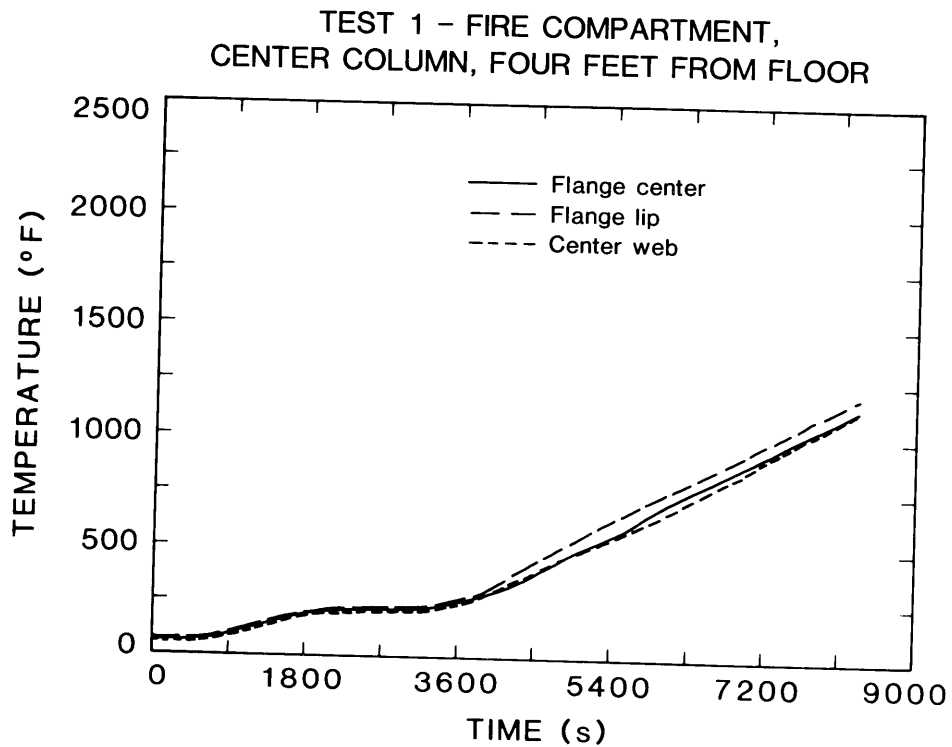
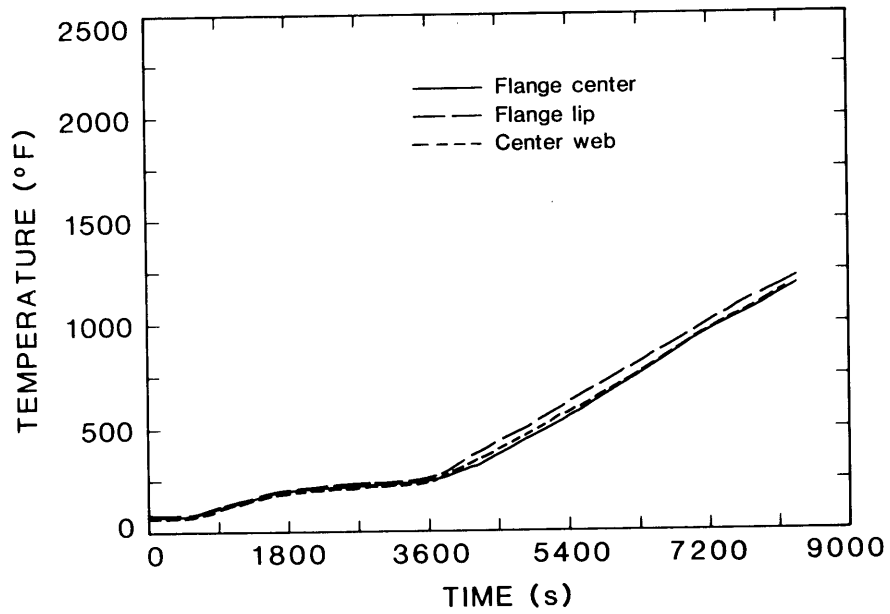
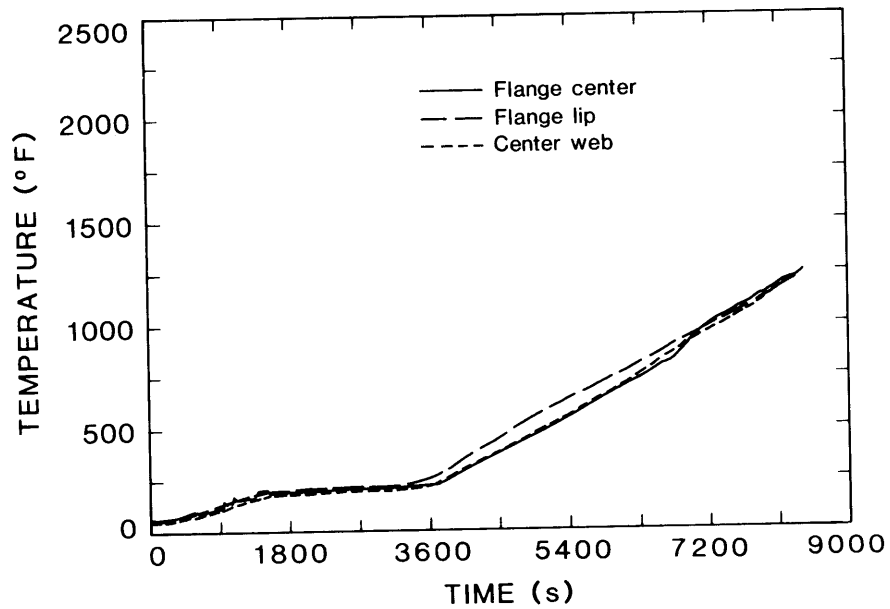
The protected W14x61 column in the fire compartment also successfully passed the NFPA 251 two hour fire test criteria with a maximum single point temperature of 1002°F. The column temperature did reach a failure point during the extended test phase at nearly 2 hours 15 minutes. This can be seen in figures 33 to 38.

Figure 33. Center column temperatures in interstitial space at measurement point two feet above walk-on deck, test 1

Figure 34. Center column temperatures in interstitial space at measurement point four feet above walk-on deck, test 1

Figure 35. Column temperatures in furnace compartment two feet up from floor, test 1

Figure 36. Column temperatures in furnace compartment four feet up from floor, test 1

Figure 37. Column temperatures in furnace compartment six feet up from floor, test 1

Figure 38. Column temperatures in furnace compartment eight feet up from floor, test 1

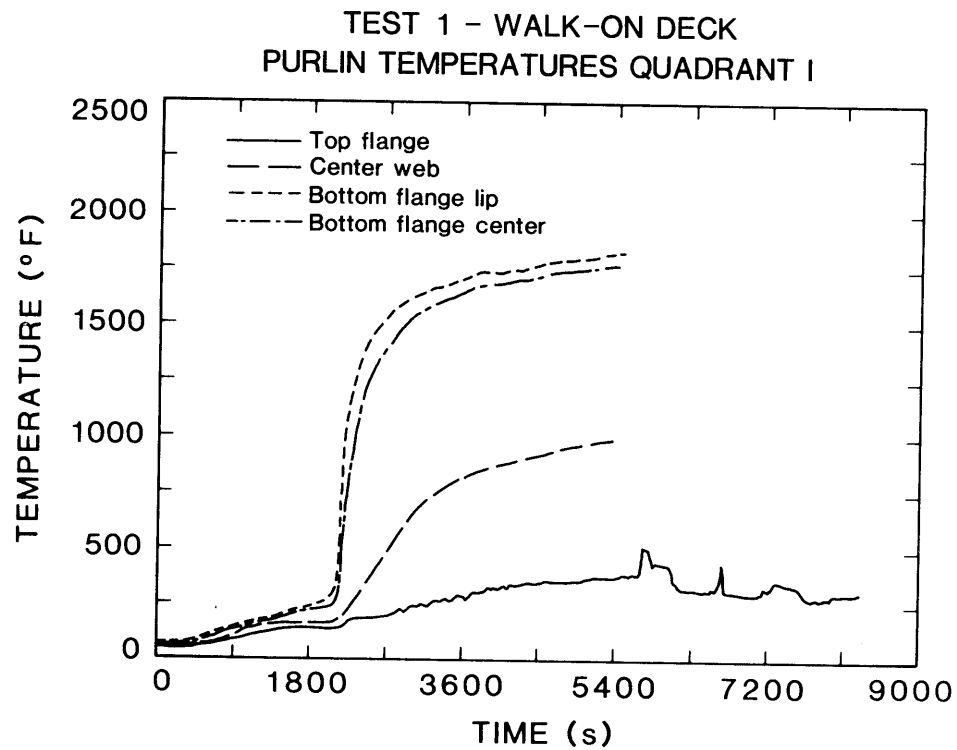
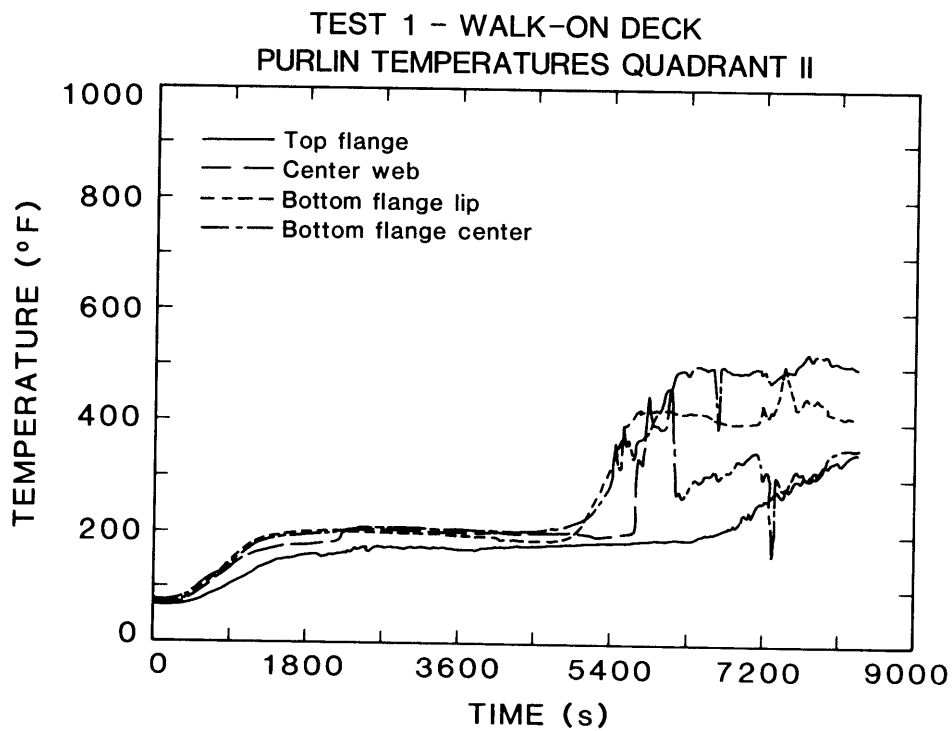
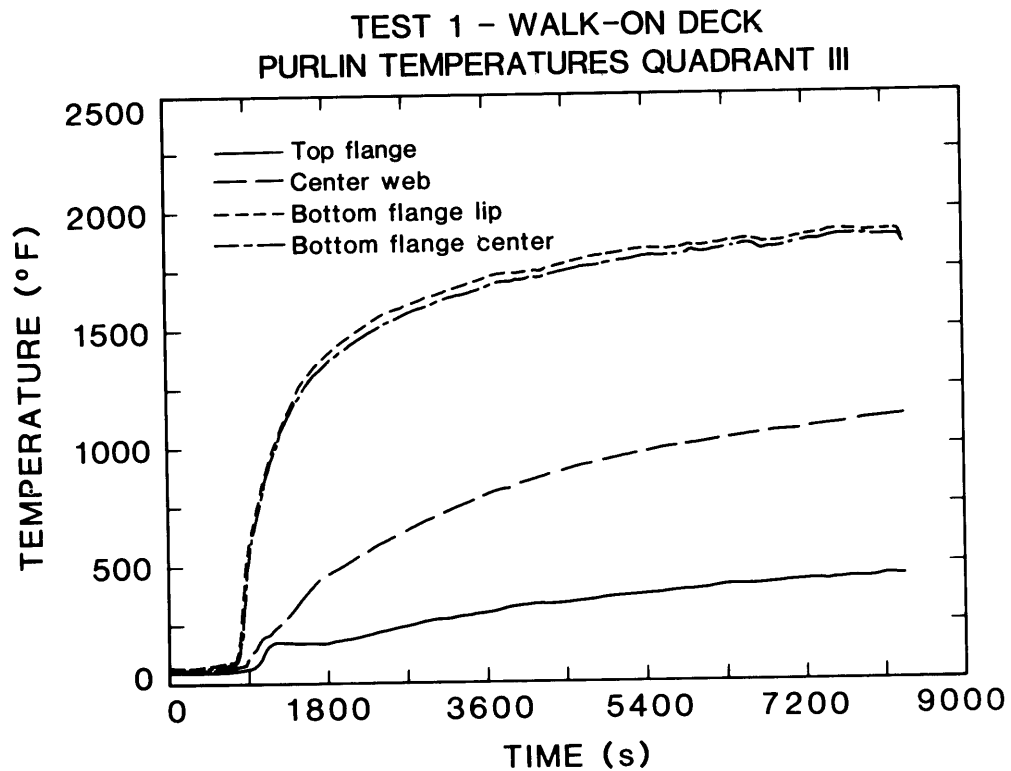
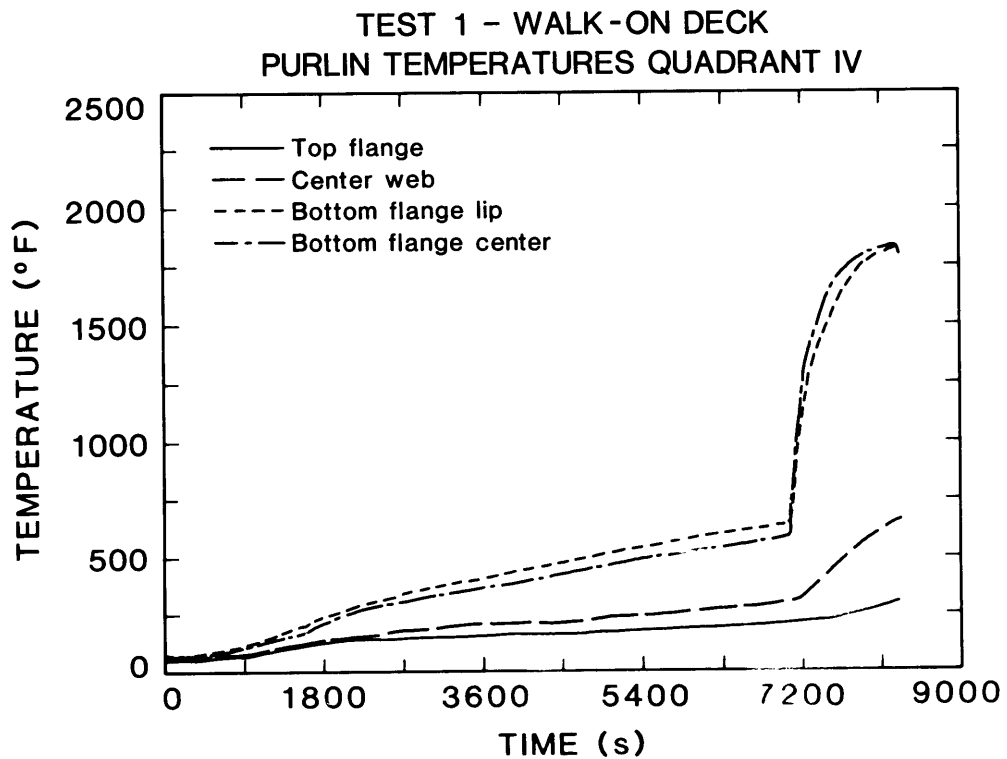
Other test data demonstrated the significant effect associated with the loss of fireproofing protecting the walk-on deck purlins. Figures 39 to 42 show the temperature history for these purlins. The purlin sections in quadrants I and III showed early temperature failures. These failures occurred at 40 and 26 minutes, respectively, resulting from fireproofing

Figure 39. Walk-on deck purlin temperatures quadrant I, test 1

Figure 40. Walk-on deck purlin temperatures quadrant II, test 1

Figure 41. Walk-on deck purlin temperatures quadrant III, test 1

Figure 42. Walk-on deck purlin temperatures quadrant IV, test 1

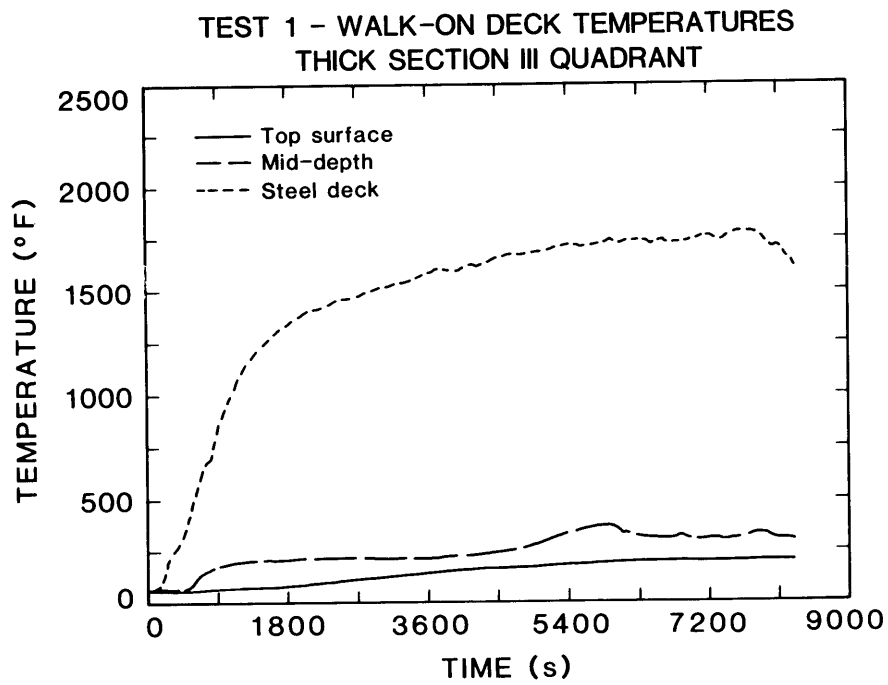
Figure 45. Walk-on deck temperatures thick section quadrant III, test 1

Figures 43 to 46 shows a comparison of walk-on deck temperatures. The high temperatures noted in figure 44 resulted from a crack developing in the walk-on deck near the measurement location. Temperatures were high enough to easily ignite cotton waste, as referenced in NFPA 251. Figures 45 and 46 show temperature rise data for a floor area that did not exhibit major cracking. In this case the surface temperatures stayed below 250°F.

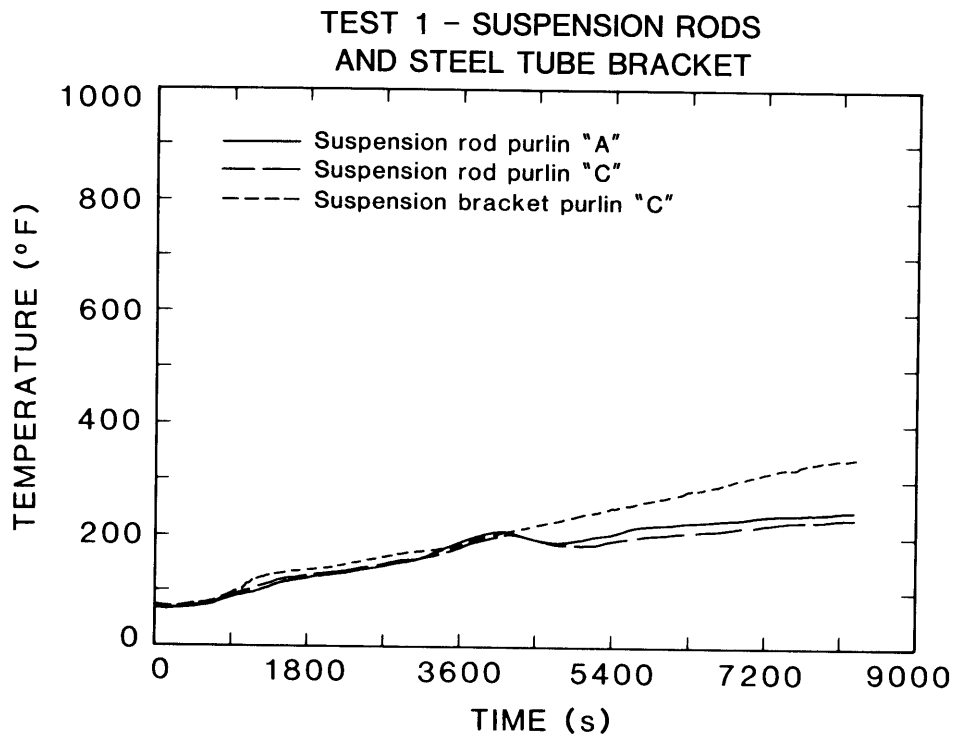
Figure 47. Temperatures for suspension rods and steel tube bracket, test 1

As stated earlier, temperature measurements were also made on two suspension rods and a steel tube bracket. Temperature plots for these construction elements are shown in figure 47. Each of these components performed well with temperatures remaining below 400°F. Figure 48 shows representative temperature data for the dummy air conditioning ducts. The large difference in surface temperatures between the supply and return ducts is attributed to the fact that the supply duct was wrapped with insulation, and the return duct was not. Figure 49 shows selected air temperature data in the interstitial space. Data obtained on deflections of the walk-on deck purlins are presented in figure 50. These deflection plots show that the purlins moved in various directions throughout the test. These data do not appear to accurately reflect the observed permanent upward bend experienced with each of the totally suspended purlins. Figure 51 illustrates an example of the 3 inch upward permanent set of purlin "C". The picture shows the suspension bracket. This unusual movement of the purlins has been studied, but no firm conclusions have been drawn. The behavior of these purlins resulted in

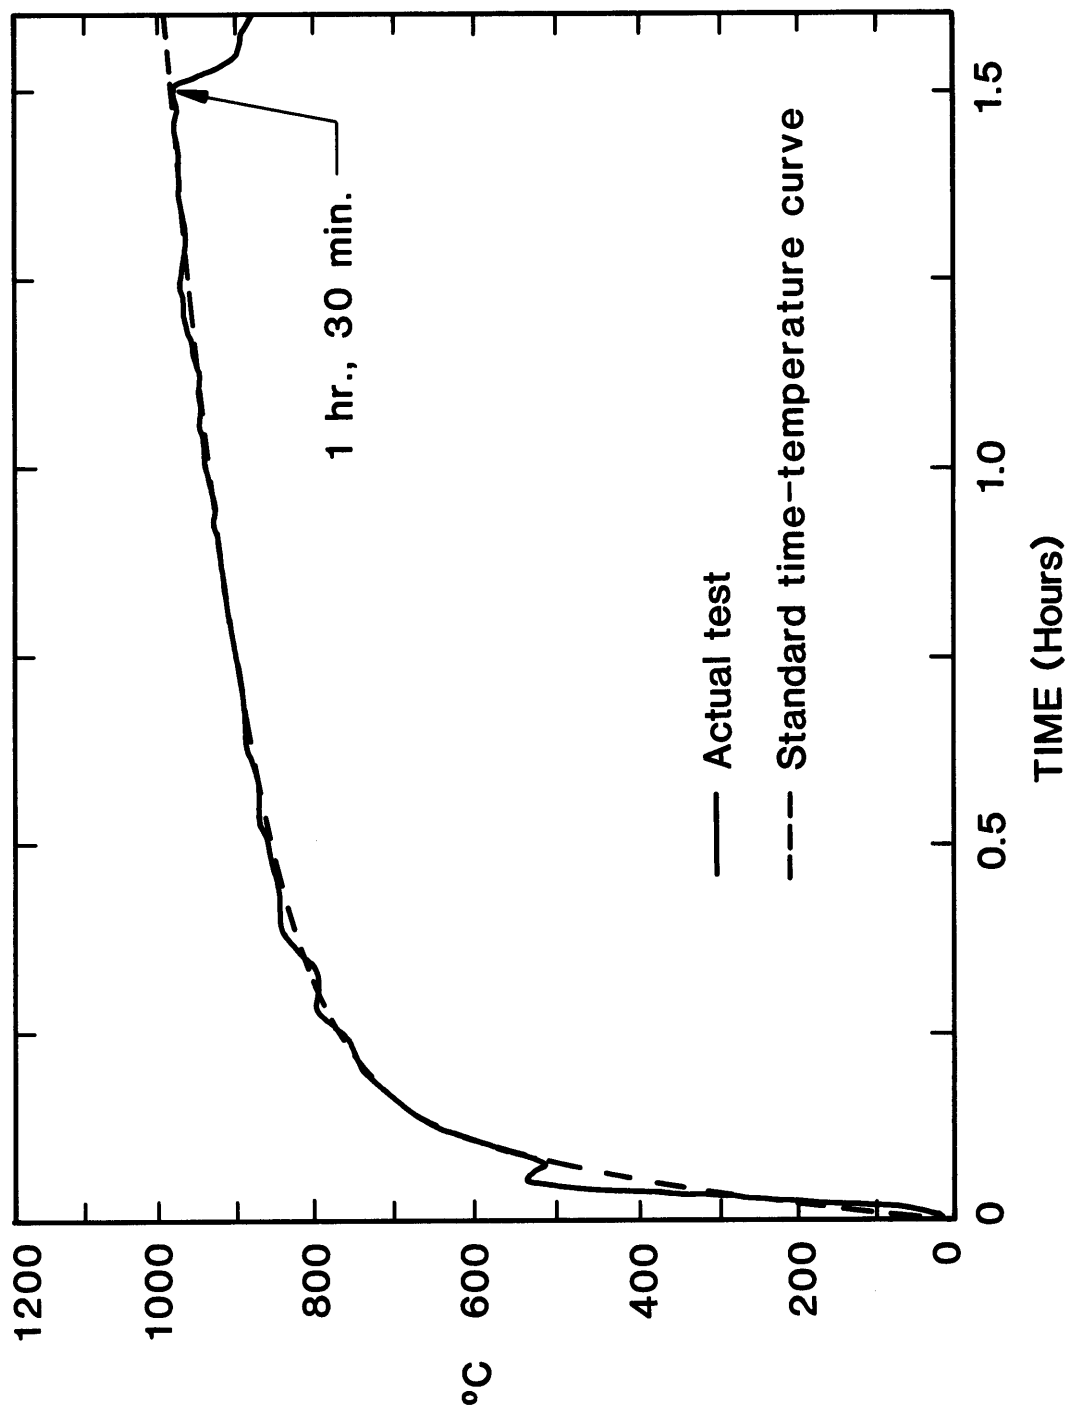
Figure 52. Chart record of average furnace temperature, test 2

A record of the average furnace temperature is presented in figure 52. This test was terminated at 1 hour 30 minutes into the test. This termination was not related to any failure of the construction assemblies under test. It resulted from the excessive heat losses from the fire compartment described in section 4.

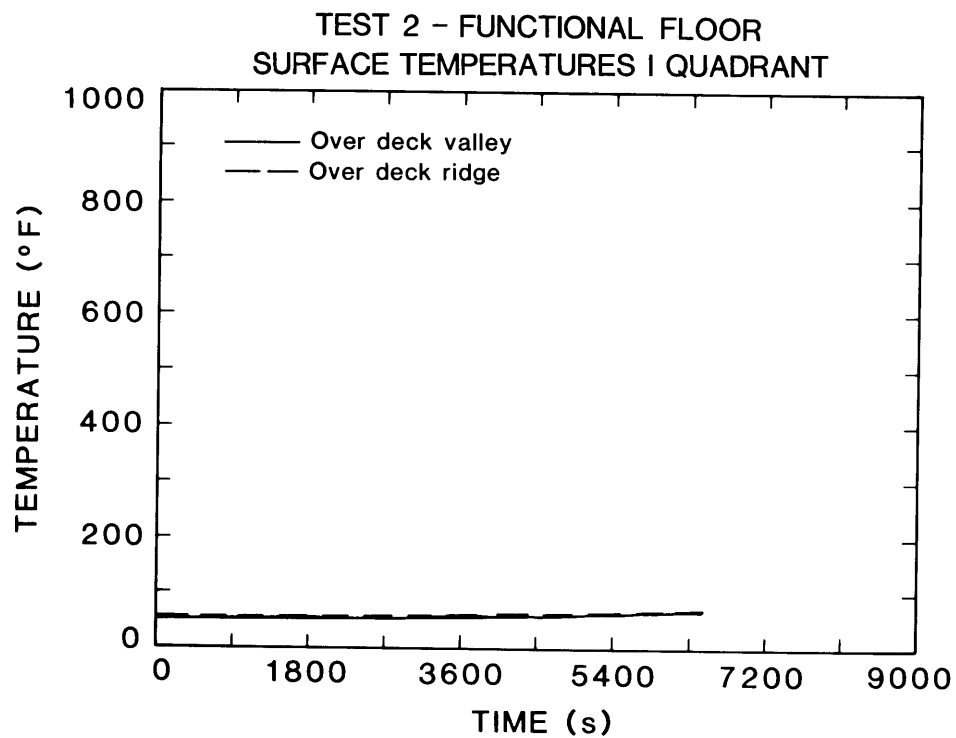
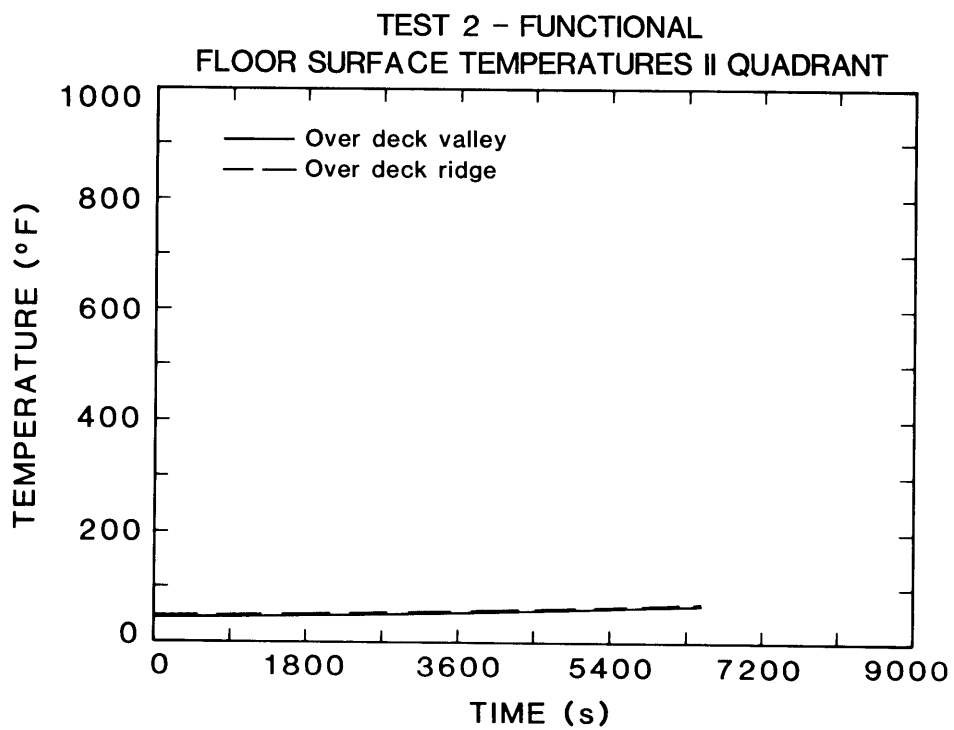
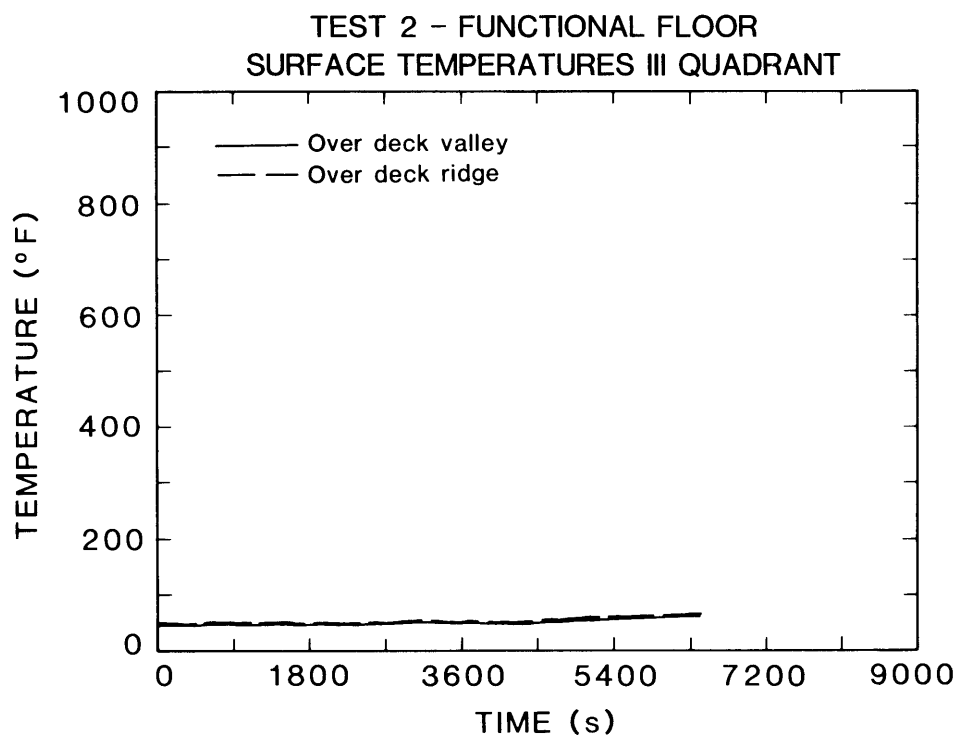
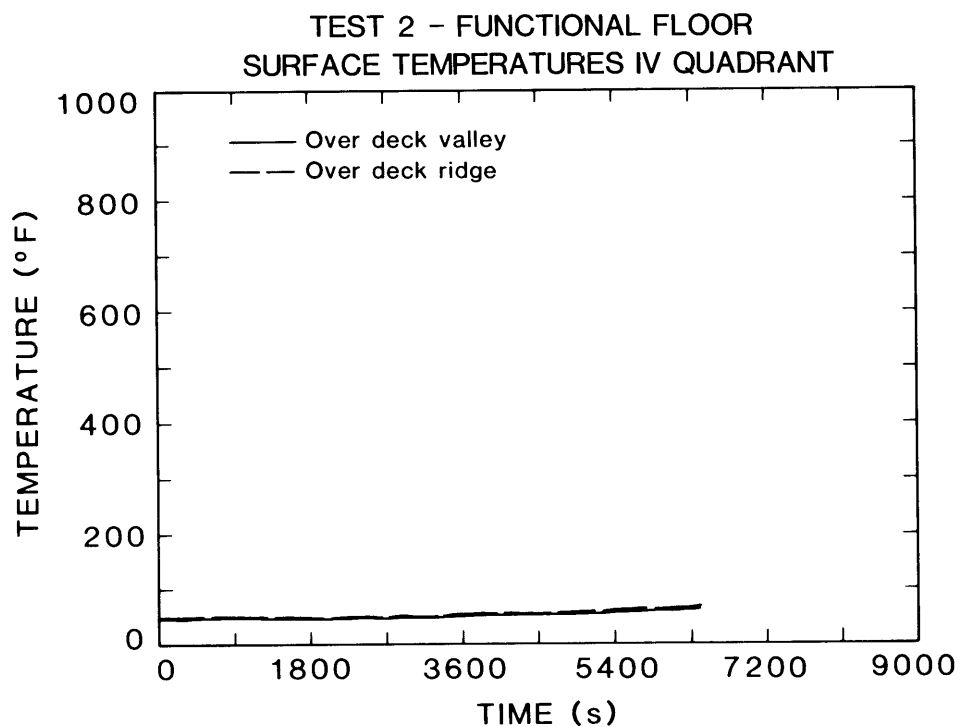
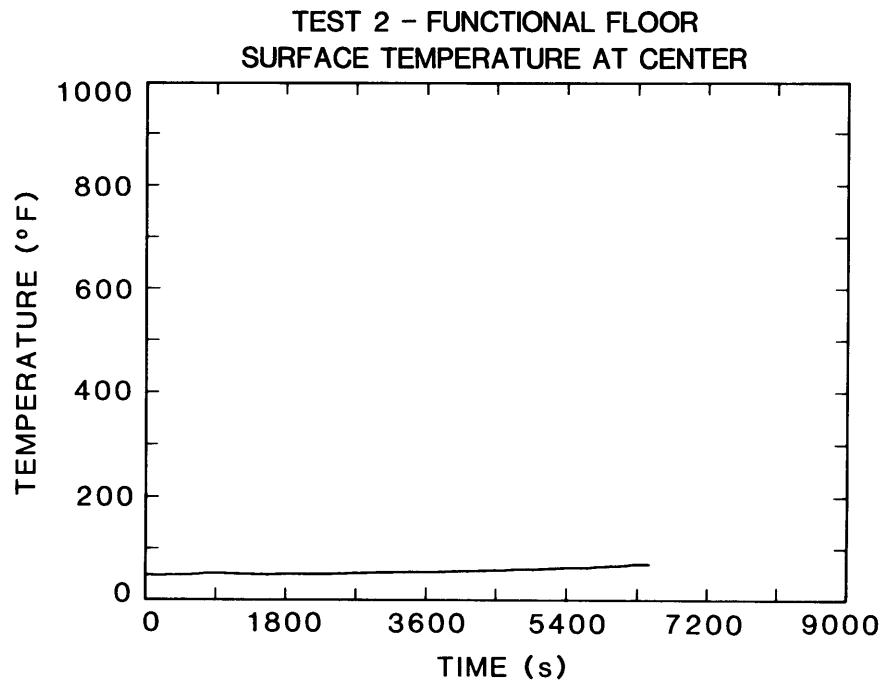
Data representative of the functional floor surface temperatures recorded during test 2 are shown in figures 54 to 58. The surface temperature from this test never exceeded 77°F. This was also well below the failure point of 250°F. The cooler surface temperatures in this test reflected the cooler weather experienced during test 1, see table 2. The steel deck temperature reached a peak of 138°F by the test's end, figure 59. The center beam supporting the function floor reached a peak temperature of 153°F, figures 60 and 61. The maximum temperature reached by the unprotected portion of the center column in the interstitial space was 165°F, figures 62 and 63. Figures 64 to 67 present plots of temperatures for the protected center column
